# Lining a canal in the United Kingdom with a bituminous geomembrane

M.TURLEY, Colas Limited, United Kingdom  
A GOSS, British Waterways

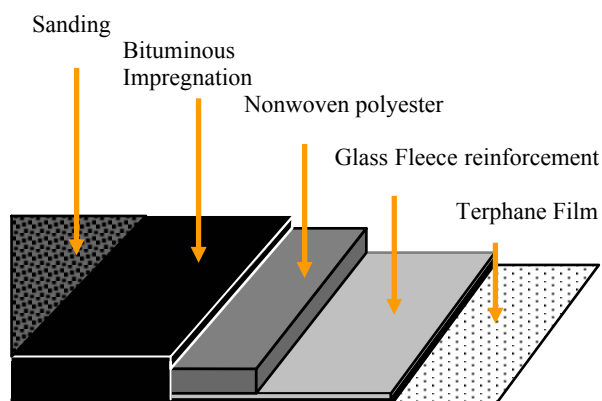
The structure of the geomembrane used is as follows (Fig 1):

- The core of the geomembrane is composed of
  - ◆ a non-woven polyester geotextile whose mass per unit area is 300 grammes per m<sup>2</sup>
  - ◆ a glass fleece reinforcement which contributes to the strength of the geomembrane and stability during fabrication
  - ◆ the whole structure is impregnated with a compound including a blown bitumen of 100/40 pen plus filler
- The underside is coated with a Terphane film bonded when the membrane is hot, and designed to give resistance to penetration from tree roots
- Finally the upper surface is coated with a fine sand to a) provide greater traction on a slope, giving greater operator safety and security from slipping, and b) to give protection from the degrading effects of UV radiation

Figure 1: Typical cross-section

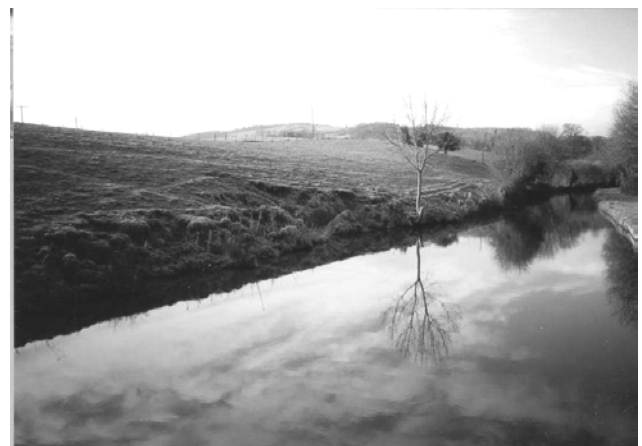
The work involved dewatering the section of canal to be repaired and forming an access point for construction plant and materials from the pasture above the canal into the canal bed (figure 1). As the Llangollen canal forms part of the important local water resource, pumps were installed to maintain the flow of water and by-pass the closed off section whilst work was in progress.

Figure 2: Access to canal from pasture (before work commenced)

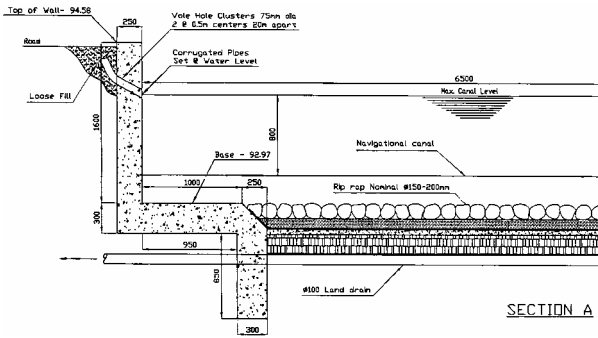
The bed of the canal was then reinforced with a layer of 28mm single sized clean, crushed, durable stone to a depth of 250mm in order to carry the weight of construction traffic (see figure 3). A 100mm-diameter land drainage pipe was installed in order to take groundwater from underneath the canal, and reduce the possibility of water lying below the new construction.

In order to provide additional protection and support an access road to properties below the level of the canal, a reinforced concrete retaining wall was constructed (see figure 3). Within this retaining wall were placed several "vole hole clusters" (see 3.2) designed to encourage the native Water Vole to re-colonize the canal and nest in the banks. The reconstruction of the retain-

Figure 3: Section of canal showing retaining wall and drainage

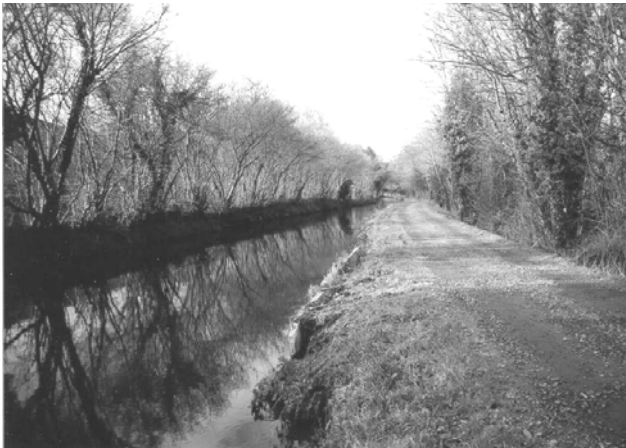
In order to enable effective waterproofing of the uphill side of the canal bank, it was necessary to remove a number of small saplings and scrub bushes. The hedgerow was also thinned to allow more light and thus encourage reed growth, the preferred food of Water Voles. Figure 4, below, shows the appearance of the bank beforehand. The old towpath and absence of retaining wall are also clear in this picture.

Figure 4: The old towpath and opposite bank showing tree growth.

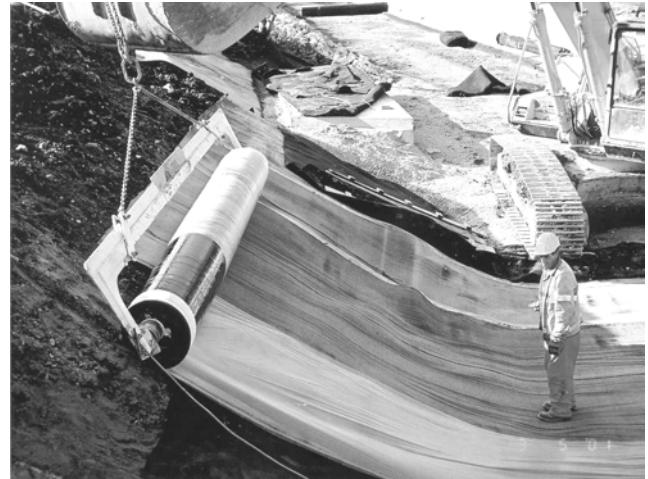
The rolls of geomembrane were transported along the bed of the canal by the use of a 30-tonne 360°-tracked excavator. A purpose-designed beam for unrolling the material was used; this allowed the heavy rolls to be maneuvered and the liner placed in position across the bed of the canal (see figure 5).

Figure 5: Unrolling the geomembrane

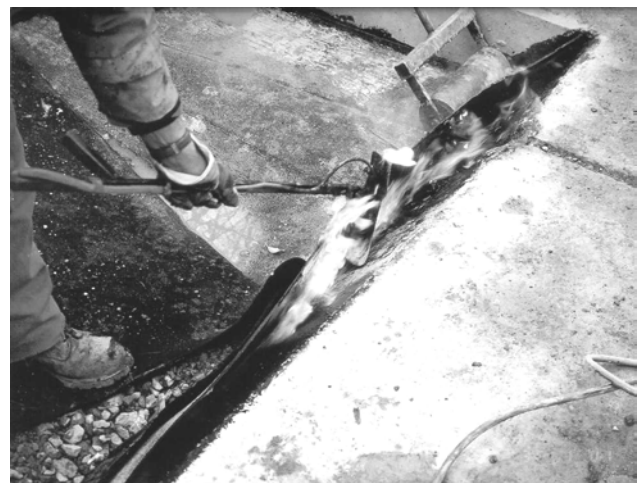
The simplicity and effectiveness of the welding method for this type of liner are a major benefit on sites such as this. The edge of each roll of liner has a 200mm strip of kraft paper incorporated along the length, which is peeled off to expose a clean edge. This edge is lifted slightly, and a propane gas torch used to heat and liquefy the bitumen. The two layers are then brought together and rolled with a light hand held roller to produce a continuous seam. The very edge is then heated and trowelled over to remove any possibility of failure. Concrete structures are treated similarly, having been previously primed (see 6.2).

Figure 6: Bonding to the concrete wall

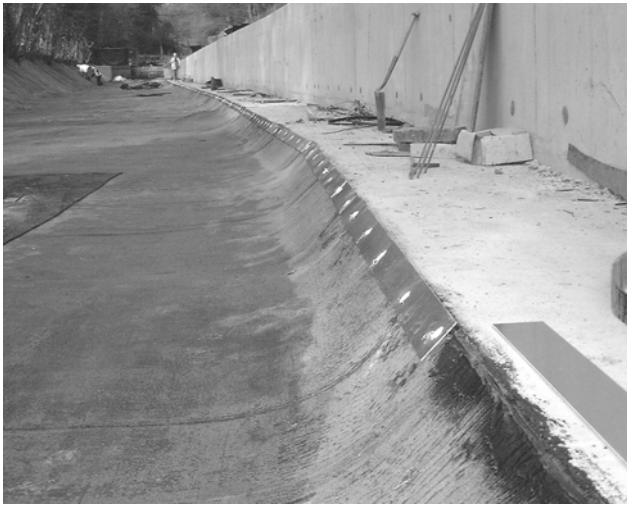
Additionally it is usual, when bonding the material to concrete structures, to reinforce the welds with a strip of aluminium or stainless steel approximately 2mm thick. This is designed to prevent the possibility of the edge of the liner becoming damaged and peeling back after time. In this case it was Hilti-Nailed to the concrete, and provides extra security for the edge at little cost (figure 7).

Figure 7: The geomembrane bonded to wall and reinforced

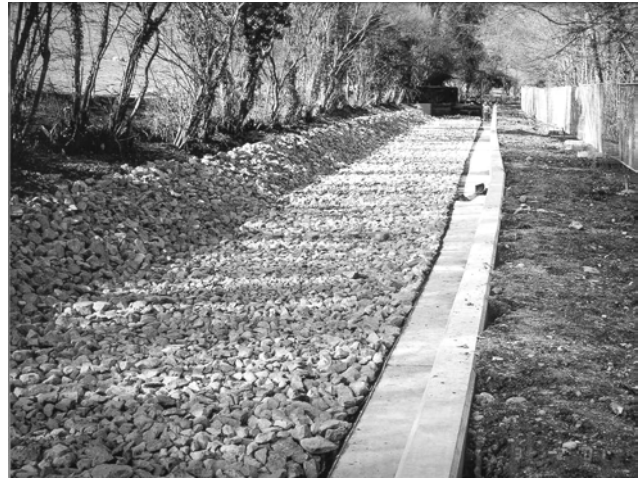
The liner was covered firstly with a geotextile protection blanket (see 6.3), and then 100mm of type 1 crushed stone. This was leveled out with an excavator as it progressed along the bed. Following this operation nominal 150-200mm diameter rip-rap stone was placed along the bed of the canal and up the bank in order to provide additional protection for the liner and, equally important, provide an aquatic habitat for water-living creatures. The completed canal bed is shown in figure 8.

Figure 8: The rip-rap placed along the bed and up the bank

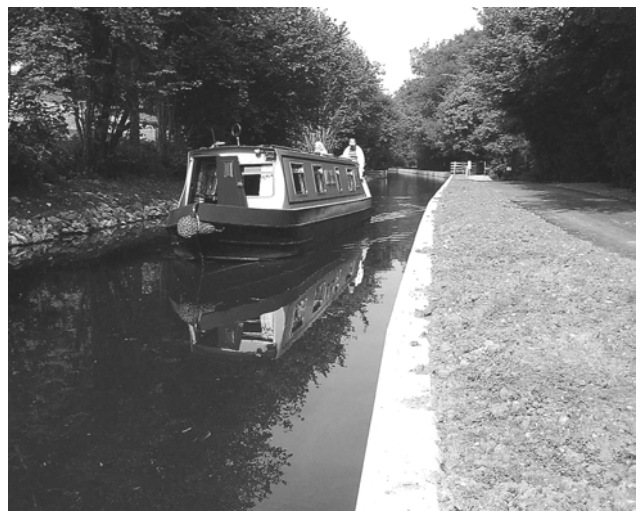
Following completion, the canal was refilled and opened up and returned to its normal use for the holiday season (figure 9).

Figure 9: The completed canal, opened to holiday traffic
